Adams Home Inspections

## HOME INSPECTION REPORT

123 Sample Street, Demo City, ST 12345

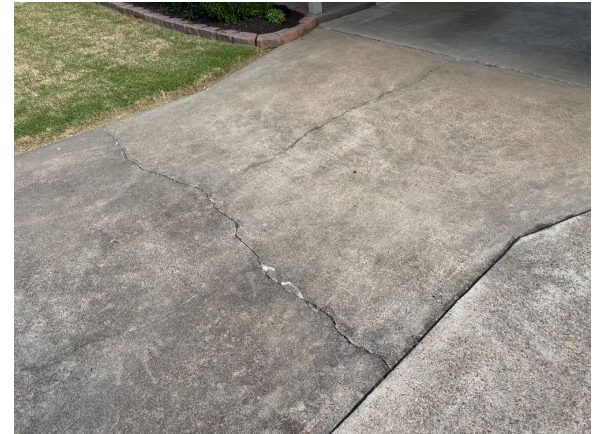
Cracks in a driveway smaller than 1/4" may not pose an immediate safety hazard, but they can still indicate potential issues with the foundation or soil beneath the driveway. Over time, these small cracks can expand and become larger, potentially leading to further damage or even failure of the driveway. It is recommended to have a professional inspect the driveway and address any cracks, regardless of size, to prevent further deterioration and potential costly repairs in the future.

Cracking in the driveway is noted. Suggest sealing.

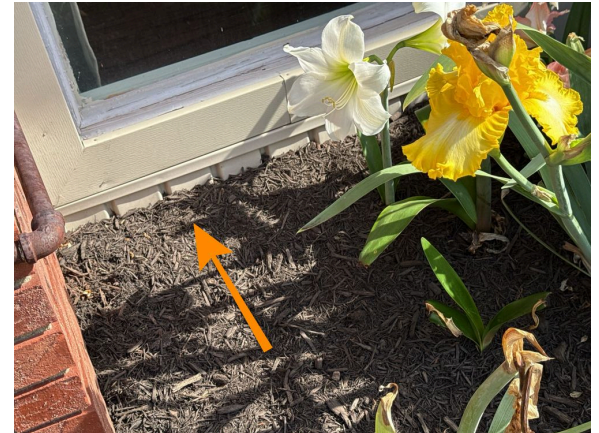
Mulch and soil are installed above bottom edge of the vinyl siding on the south side. This may allow moisture penetration into the structure in this area.

At the time of the inspection, it was noted some wood siding was in direct contact to the ground. Recommend the clearance at least an inch between the soil and the siding to prevent water leaking and water damage. Improvement strongly recommended.

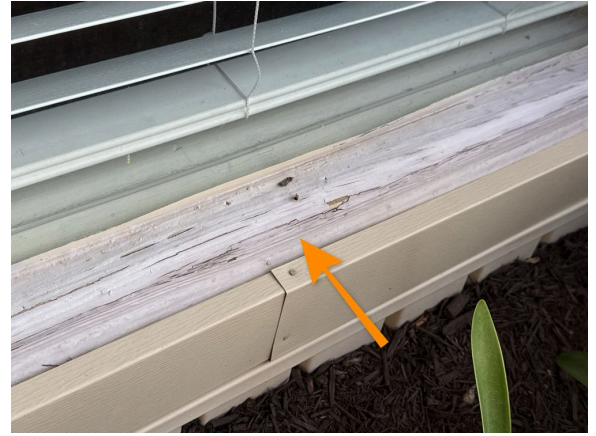
During the home inspection, it was noted that the window trim on several exterior windows appears to be in need of painting or repainting. The trim, which is typically made of wood, showed signs of fading, chalking, and peeling paint. The color of the trim is also faded, indicating that it has been some time since it was last painted. This issue is likely caused by exposure to the elements, such as sun, rain, and wind, which can cause the paint to degrade over time. The fading and chalking of the paint is indicative of weathering and UV damage. It is recommended that the homeowner address this issue by repainting or re-staining the window trim as soon as possible. This will not only improve the aesthetic appearance of the home but also protect the wood trim from further weathering and potential water infiltration. Before applying new paint or stain, it is important to properly prepare the surface by cleaning, scraping, and sanding the trim to remove any loose paint, dirt or mold. It is also important to use the proper paint or stain and primer for the type of wood and to apply it in the recommended number of coats. It's also important to note that window trim not only serves as an aesthetic component of a home but also helps to protect the home from water infiltration and weathering. This issue should be addressed and fixed as soon as possible to ensure the longevity of the window and surrounding wall.

Wood trim component at front window needs to be repainted.

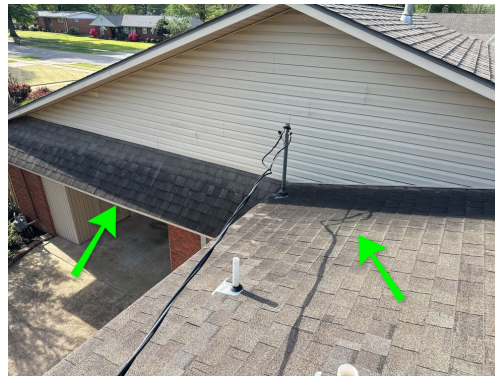
During the inspection, the roof was thoroughly examined and it was determined that it is in average condition. The inspection included a visual examination of the roof's condition from the ground, as well as an examination of the roof's interior components such as the attic and the insulation. During the inspection, some issues were identified that may need attention in the future. The roofing materials appeared to be in fair condition with some signs of wear and tear, such as missing, curling or cracked shingles. The flashing around penetrations such as the chimneys, vents, skylights, and other protrusions were inspected and some signs of rusting, cracking or leakage were identified. The gutter system and downspouts were also examined and found to have some clogging and gutter sag. The overall condition of the roof suggests that it has been well-maintained to some extent, but it also indicates that it may need repairs or replacement in the near future. The age of the roof was also taken into account and it looks to have less service life left than a new roof. It is important to note that even though the roof appears to be in average condition, it is still important to keep up with regular maintenance, such as cleaning gutters and downspouts, and inspecting the roof periodically for any potential issues. Homeowners are advised to address the identified issues as soon as possible and budget for repairs or replacement in the near future.

Couple of areas show repair or shingle replacement. Typical north facing fungal growth type staining noted

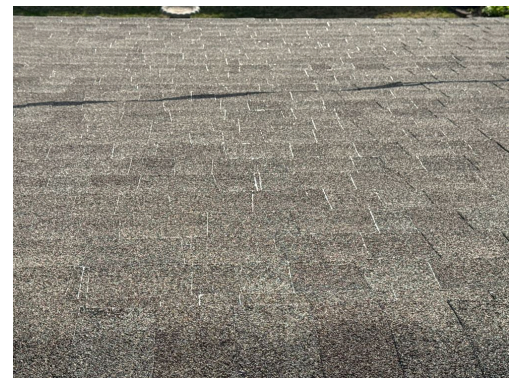
Areas of granular loss and/or wind damage was noted. Suspect roof covering is near end of life expectancy. Suspect replacement will be needed soon

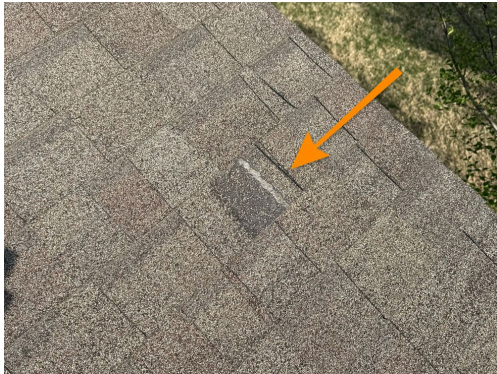
During the home inspection, it was observed that there are areas of damage to the roof coverings. These damages can be caused by a variety of factors such as weather events, age, and improper installation. Damaged coverings can include missing or cracked shingles, missing or loose tiles, or damaged or missing flashing. These damages can allow water to penetrate the underlayment and cause leaks, which can lead to damage to the structure of the home. It is important to address damaged coverings as soon as possible to prevent further damage to the roof and home. It is recommended that the homeowner have a roofing professional evaluate the damaged coverings and make any necessary repairs.

Damaged shingle with exposed fiberglass noted on east side of carport.

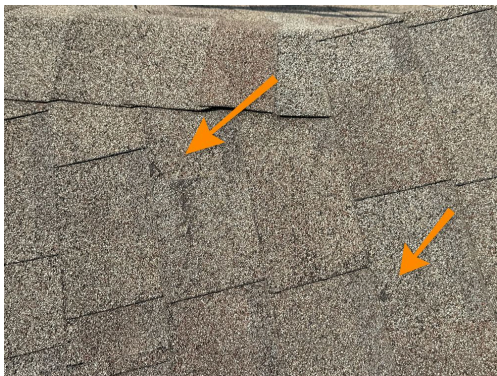
Minor damage with no penetration noted on east slope of carport

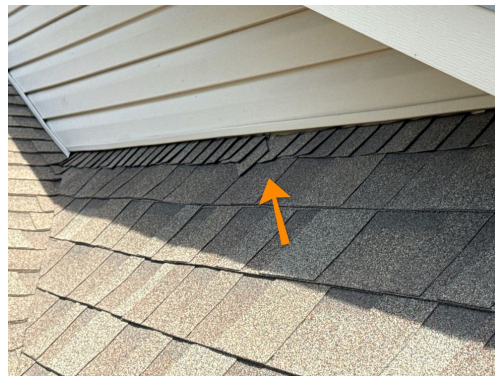
Minor loose trim shingle noted over carport

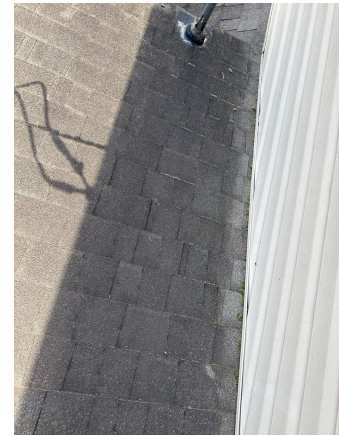
During the home inspection, it was observed that there is moss growth on the roof. Moss growth on a roof is not only unsightly, but it can also be a sign of a larger problem. Moss thrives in moist environments, so its presence may indicate that there is a problem with drainage or ventilation on the roof. Moss growth can also hold moisture against the roof coverings, which can cause them to deteriorate prematurely. This can lead to leaks and other damage to the roof and the home. Moss growth on a roof can also be slippery and create a safety hazard for anyone walking on the roof. It is recommended that the homeowner have a roofing professional evaluate the moss growth and make any necessary repairs to address the underlying problem and remove the moss.

Moss growth is noted north side is shaded.

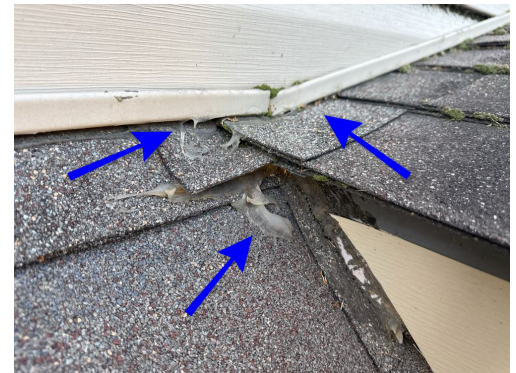
During the inspection, it was observed that sealant had been applied to certain areas of the roofing material. Sealant is not recommended for use with the type of roofing material present on the property. Generally speaking, the use of sealant is more of a temporary fix that should be removed once a more permanent repair is imminent.

Sealant has been installed in multiple locations at this intersection. Note see flashing comment for water penetration.

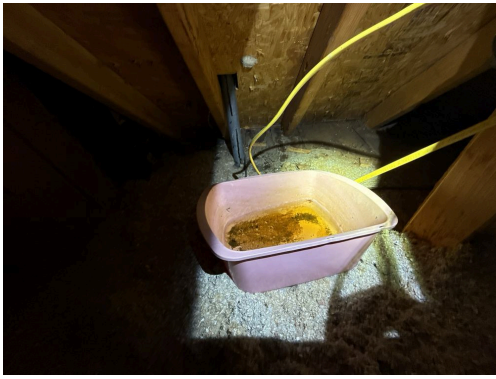
At the time of the inspection was noted the roof wall flashing at the house was incomplete. This incompleteness has to do with missing mortar or missing flashing material at the roof and wall junction. No indication of water penetration was noted at the time of the inspection. However, if this is not corrected, overtime, there could be water intrusion and moisture damage. Recommend repairing as needed by technically competent contractor.

A plastic pan with noted water standing is noted near the overhead power penetration area where the roof and wall intersect.

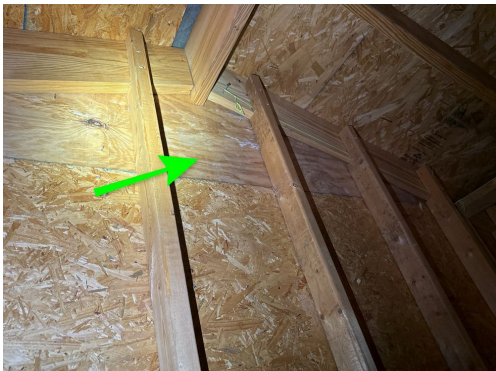
Gable event is not visible inside the attic space

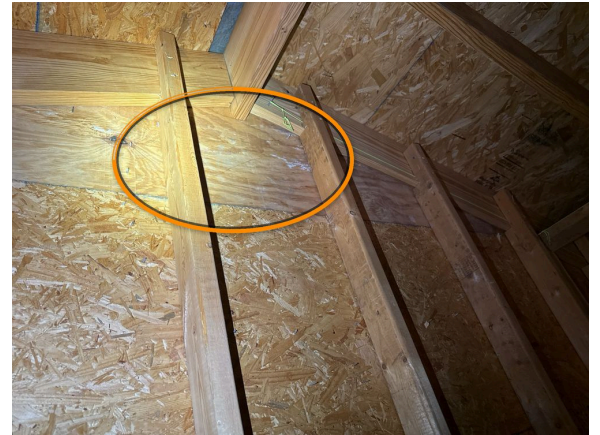
During the inspection of the property, it was observed that the attic ventilation was insufficient. Adequate ventilation in the attic is crucial for maintaining the health and longevity of the attic and the framing components of the home. Without adequate ventilation, the attic can become hot and humid, leading to several problems such as: Shortening the lifespan of roofing materials, Warping and rotting of framing components, Condensation and mold growth in the attic, Increased energy costs due to the load on the air conditioning system, Pest infestation. There are several types of attic ventilation, such as gable vents, soffit vents, ridge vents and turbine vents. The most common method is the balanced method, which is a combination of soffit vents and ridge vents. They work together to provide fresh air to the attic while removing warm, moist air. To prevent these issues and ensure proper attic ventilation, it is recommended to consult with a professional to evaluate the current ventilation system, and if necessary, to install additional ventilation in the attic. A professional should be consulted to ensure that the job is done properly and safely, and that the attic has enough ventilation. Note: suggest opening gable vents on front of house, adding gable vent over North gable over service line area and possibly adding a power vent fan to rear section of house to hopefully pull air through. Solar powered vent fan may be an option.

Gable vents installed on front of house are blocked. No ventilation here.

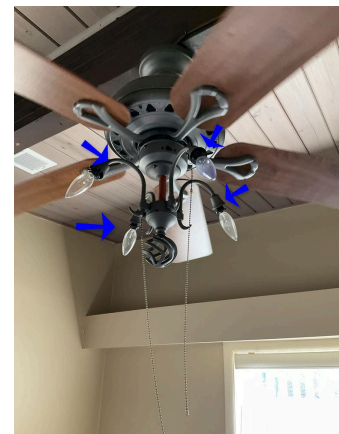
During the home inspection, it was noted that there is missing bulb protection present. Missing bulb protection, such as wire guards or globes, can pose a safety hazard by exposing the light bulb and potentially causing damage or injury. It is recommended to add missing bulb protection to ensure the safety and proper function of the lighting fixture. This may involve installing wire guards, globes, or other types of protective coverings to prevent accidental contact or damage to the bulb. Regular maintenance and inspection of lighting fixtures is essential for both safety and energy efficiency, and can help to prevent potential hazards such as electrical fires or shocks. It is recommended to have a qualified electrician or handyman evaluate and repair any issues with lighting fixtures, including missing bulb protection, as soon as possible to ensure the safety and proper function of the property.

Bedroom two light missing globes

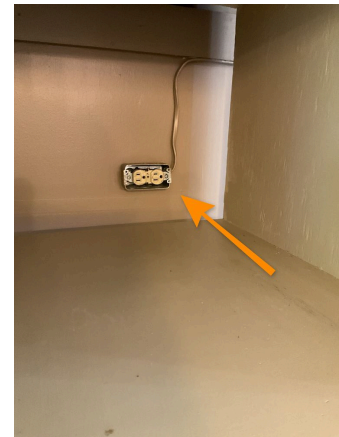
It is important to cover any missing light switch or receptacle covers as soon as possible to prevent these hazards and ensure the safety of the inhabitants of the home. This can be done by installing a new cover, which can be purchased at most hardware stores. It is also important to hire a licensed electrician to inspect the wiring and ensure that it is safe and properly installed.

Outlet for refrigerator

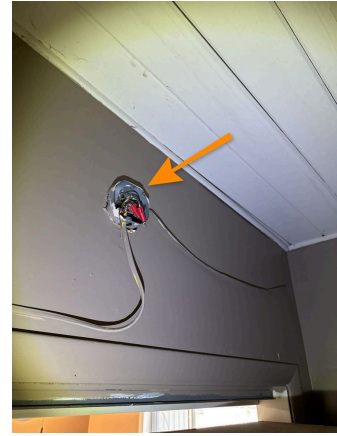
An uncovered electrical junction box is a serious safety hazard in a home, as it exposes live wires and electrical connections to the elements, and can lead to serious accidents such as electrical fires, electrocution, and power outages. Some of the dangers associated with an uncovered electrical junction box include: **Electric Shock:** If a person comes into contact with the live wires inside an uncovered junction box, they can receive an electric shock, which can be potentially fatal. **Fire Hazard:** Exposed wires in an uncovered junction box can create a fire hazard, especially if they come into contact with flammable materials. **Damage to Electrical Devices:** Exposed wires in an uncovered junction box can cause damage to electronic devices and appliances, which can be costly to repair or replace. **Short Circuit:** Exposed wires in an uncovered junction box can cause a short circuit, which can disrupt the power supply to the entire home and cause a fire hazard. **Injuries:** Exposed wires in an uncovered junction box can cause injuries to people and pets if they come into contact with them. It is important to cover an uncovered electrical junction box as soon as possible to prevent these hazards and ensure the safety of the inhabitants of the home. This can be done by installing a junction box cover, which can be purchased at most hardware stores. It is also important to hire a licensed electrician to inspect the wiring and ensure that it is safe and properly installed.

Junction box in closet in dining room

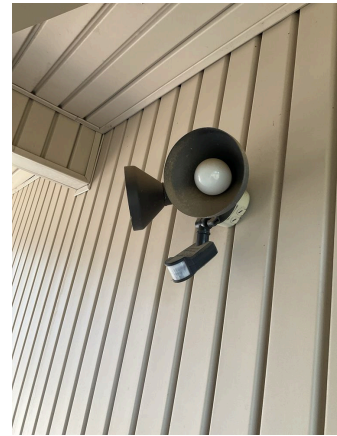
During the inspection, it was observed that the exterior porch light was inoperable. The cause of the malfunction could not be determined at the time of the inspection. It is recommended that a qualified electrician evaluate the issue and make necessary repairs or replacements to ensure proper functionality and safety. Additionally, consider using energy-efficient lighting options, such as LED bulbs, to reduce energy consumption and increase the lifespan of the light fixture.

Carport light

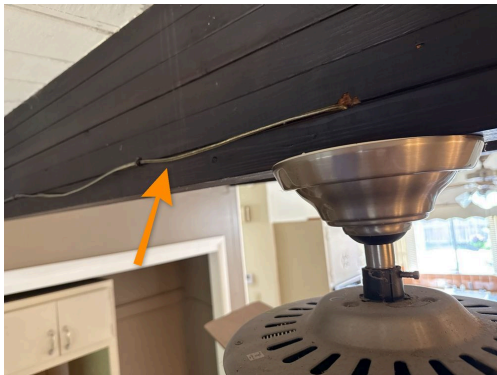
Lamp wiring was observed being used as a permanent electrical installation. Flexible lamp cord is not intended for fixed building wiring and can be more susceptible to physical damage, overheating, and fire hazards. This condition is considered improper and does not meet modern safety standards for permanent wiring methods. I recommend correction by a qualified **electrical contractor** to replace the lamp cord with an approved permanent wiring method.

Lamp cord wiring in use for permanent installation

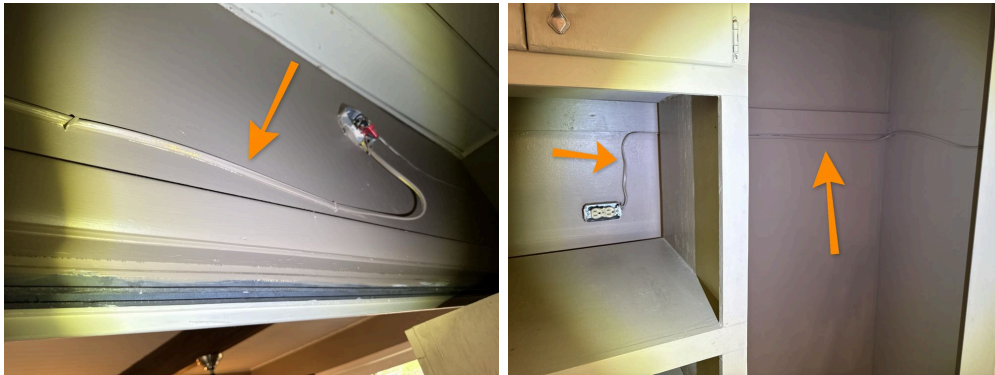
Exposed branch circuit wiring was observed at the time of inspection. Electrical conductors that are not properly enclosed or protected present an increased risk of shock, short circuit, and physical damage. This condition is considered a safety concern and does not meet generally accepted modern safety standards for protected wiring methods. **Recommendation:** Have a qualified *electrical contractor* evaluate and properly protect or repair the exposed wiring as needed.

Dispose and circuit wiring noted in closet in dining area

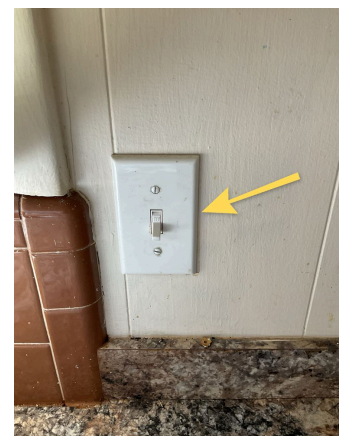
There are several known switches throughout the house. It is not possible to determine what they go to at the time of the inspection recommend and inquiring with previous owner or builder.

Kitchen unidentified switch noted

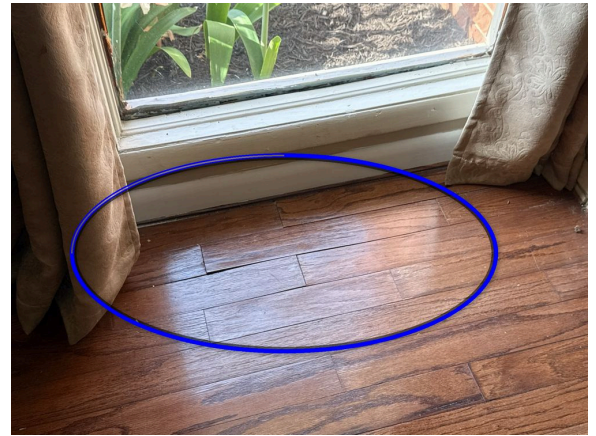
The inspector noted during the inspection that the flooring material in the home was not properly secured. This type of issue can occur due to a variety of factors, including improper installation, settling of the building, or exposure to moisture. To address this issue, the inspector recommended that a qualified flooring contractor be consulted for repair. Unsecured flooring material can cause a variety of problems, including tripping hazards, difficulty with furniture placement, and potential damage to the subflooring. To ensure that the flooring is safe and functional, a qualified contractor should be consulted to assess the cause of the unsecured flooring and recommend the best course of action to address the issue.

Loose flooring is noted near the living room front window. Moisture testing in this area did not produce any visual wet spot. Monitor this area, possibly window previously leaked.

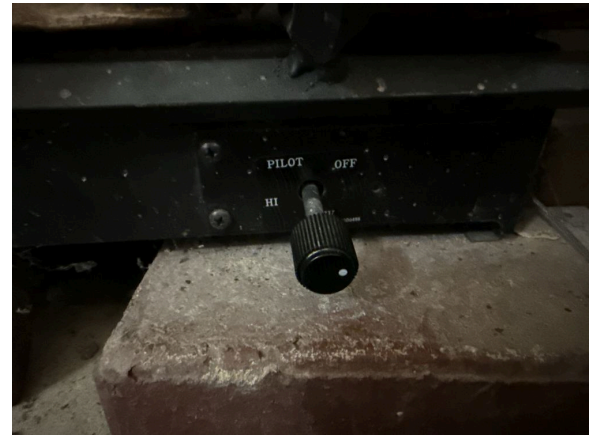
During the home inspection, it was noted that the gas valve was in the off position, the gas was empty, or the gas regulator was inoperable. When attempting to test the gas supply by depressing the pilot switch, there was no audible sound or smell of flowing gas. It is recommended to have a licensed HVAC technician or plumber evaluate the gas supply system to determine the cause of the issue and make necessary repairs. It is important to address any issues with the gas supply as soon as possible to prevent potential safety hazards, such as gas leaks or carbon monoxide poisoning. Only a qualified professional should work on gas supply systems.

Control valve is in the off position.

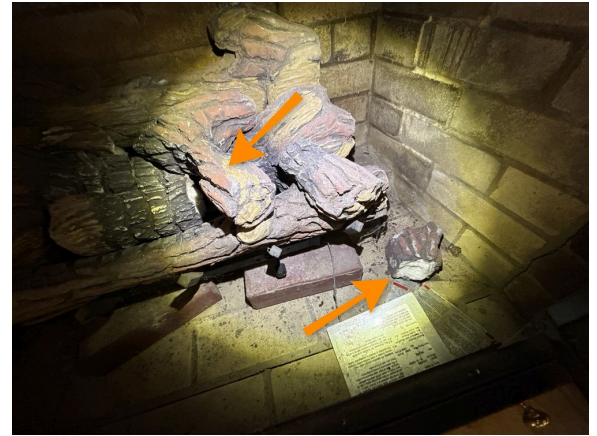
During the home inspection, it was noted that portions of the fireplace appeared to have areas of visible damage. It is recommended to have the fireplace inspected and repaired by a qualified mason or fireplace contractor to determine the extent of the damage and make any necessary repairs. This may involve repairing or replacing damaged masonry or components, such as the firebox or chimney liner, to ensure that the fireplace is structurally sound and safe for use. Regular maintenance and inspection of fireplaces is essential for both safety and energy efficiency, and can help to prevent potential hazards such as chimney fires or carbon monoxide buildup. It is important to address any issues with fireplaces as soon as possible to ensure the safety and livability of the property.

Broken decorative log piece noted

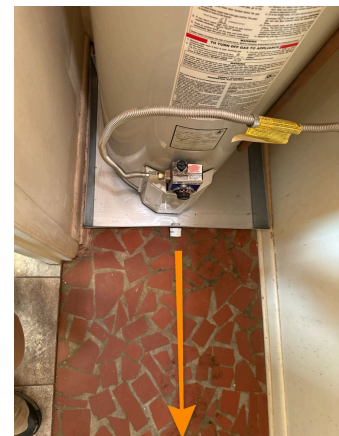
**11.2.5 Drip Pan - drain line Missing**

Emergency drain pan does not have a drain line to the exterior.

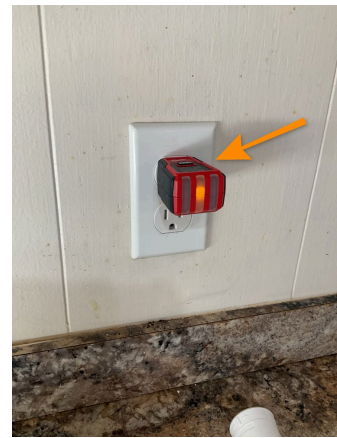
No GFI in kitchen

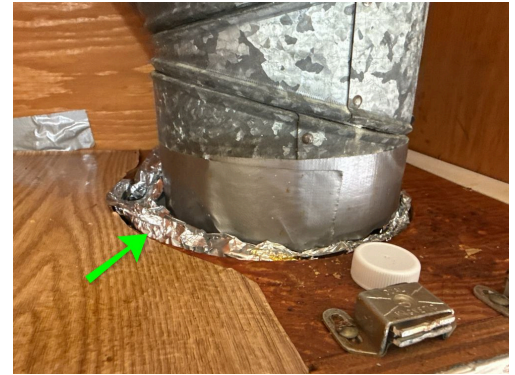
Unconventional installation noted.

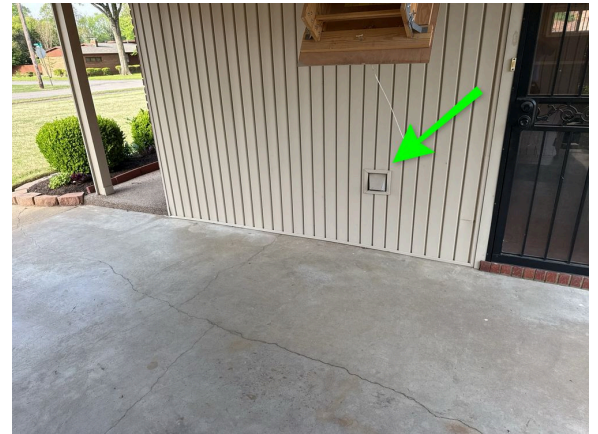
Dryer vent is located under the carport

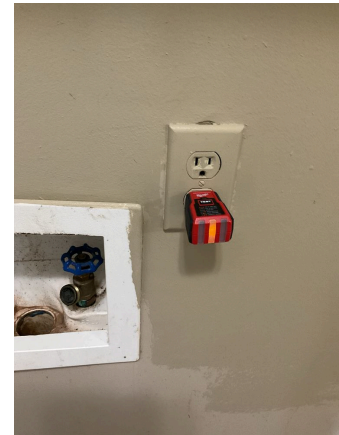
Laundry room no GFCI
